**STINSON LAKE DAM
NH 00399**

**PHASE I INSPECTION REPORT
NATIONAL DAM INSPECTION PROGRAM**

OCTOBER 1978

Name of Dam: Stinson Lake Dam, I.D. NH 00399
State Located: New Hampshire
County Located: Grafton
Stream: Stinson Brook
Date of Inspection: June 5, 1978

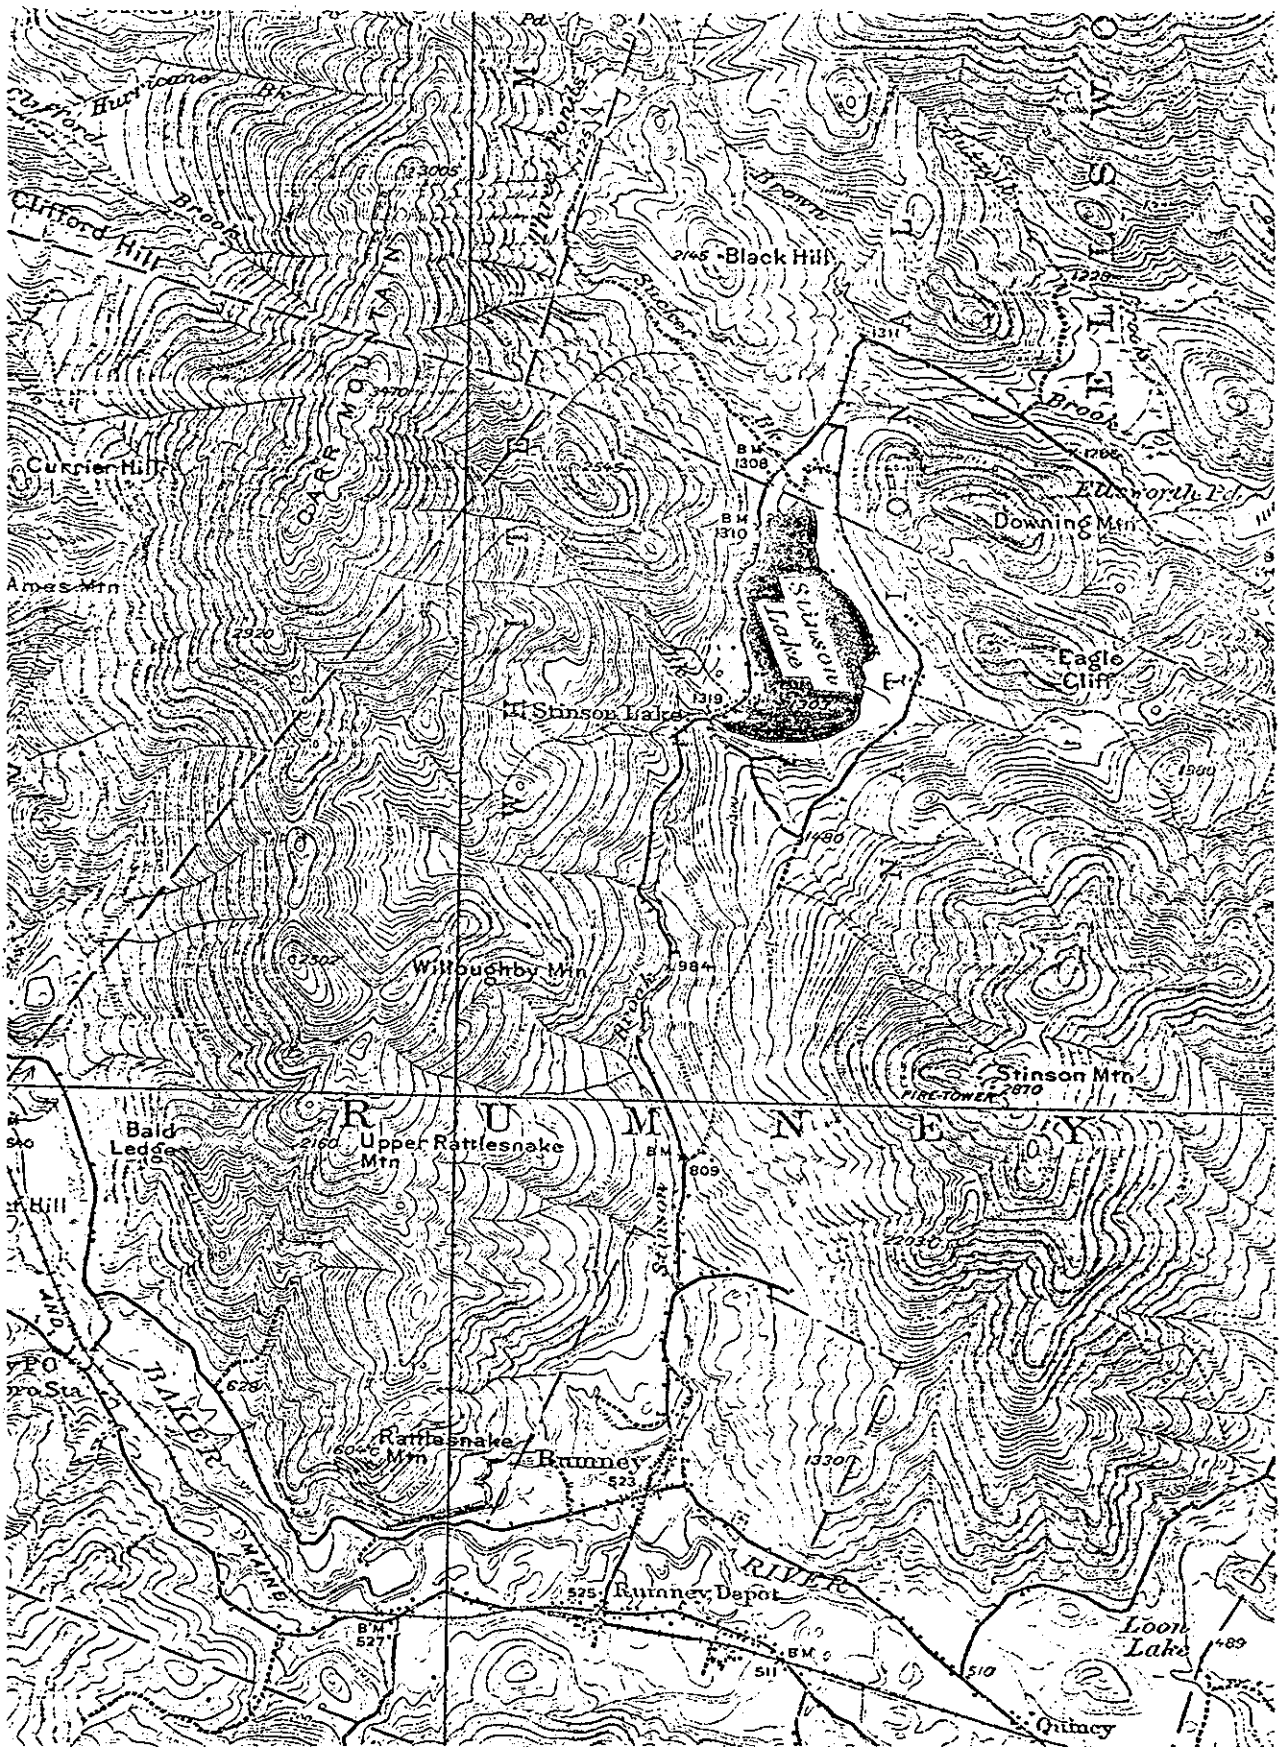
STINSON LAKE DAM

Looking toward the right abutment. The low level outlet stop plank section is in the foreground, on the left abutment.
